## Airworthiness Directive

**AD No.:** 2015-0226R3

**Issued:** 01 June 2016

### ATA 25 – Equipment / Furnishings – Hoist – Test / Replacement

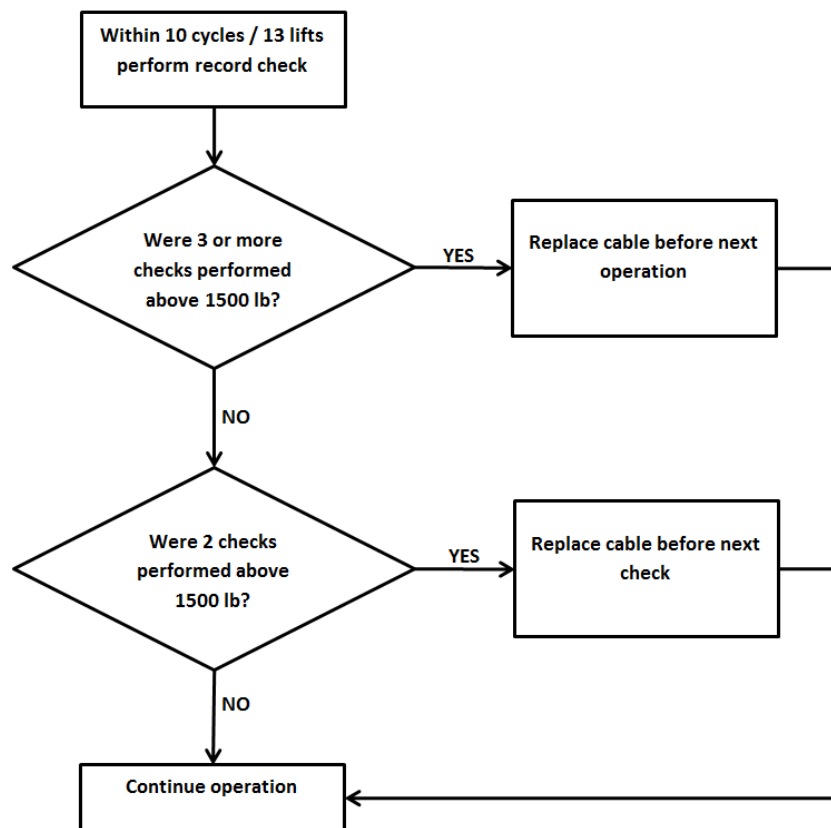
Figure 1

- (1) Within 10 hoist operating cycles or 13 hoist lifts (as applicable, see Note 1 of this AD) after 21 November 2015 [the effective date of the original issue of this AD], determine the P/N of the hoist installed on the helicopter and, if a Goodrich hoist is installed with a P/N listed in Table 1 of this AD, accomplish a records check to determine whether, during any previous hoist load check/test, a cable was load-tested (average of 5 pulls) at 1 500 lb [680 kg] or more. If any cable is identified to have exceeded this limit during three or more hoist load checks/tests, before next hoist operation, replace the affected cable with a serviceable cable. If any cable is identified to have exceeded this limit during two hoist load checks/tests, before the next hoist load check/test, replace the affected cable with a serviceable cable. For replacement of a cable, see figure 1 (flowchart) of this AD.
